## Arboricultural Report

### Tree risk assessment and recommendations:

Trecarne, Falmouth

**Client:** Cornwall Housing

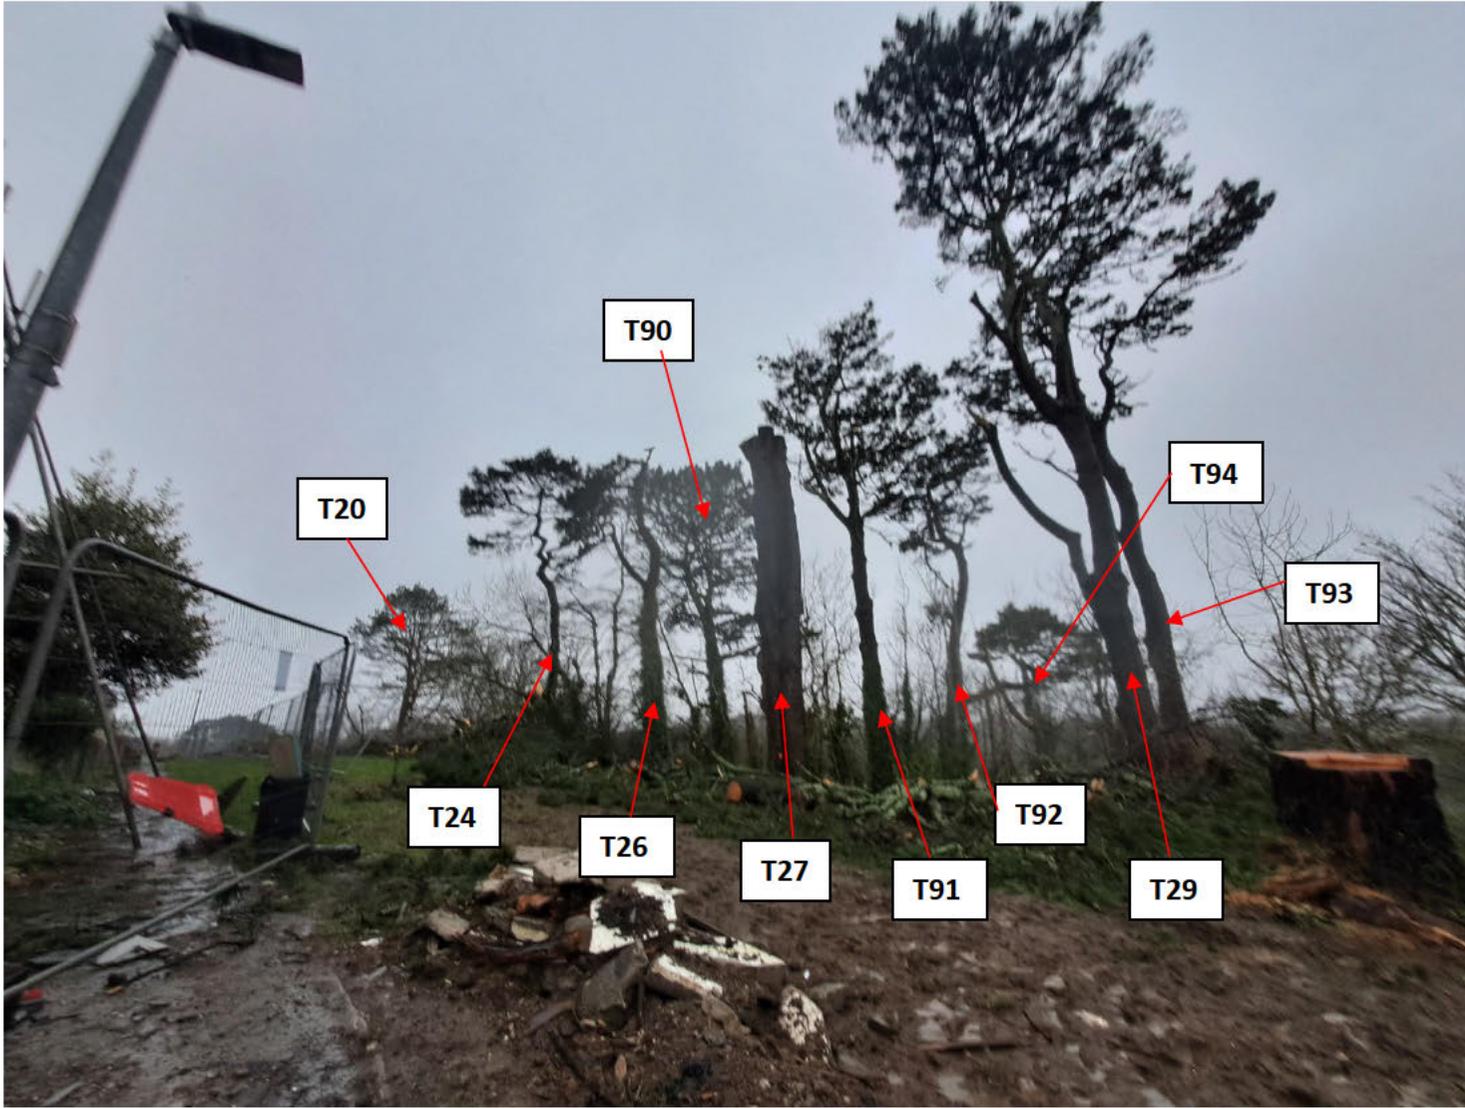
Image 1. Remaining trees on site at Trecarne.
